Manhole Inspection Summary

Manhole # S37CC_049MH

Insp Date: **8/25/09 11:12 PM**

Location Address: **418 E.Eager St.**

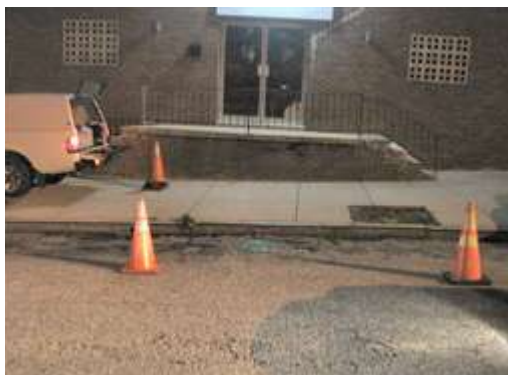
Location View

View facing north

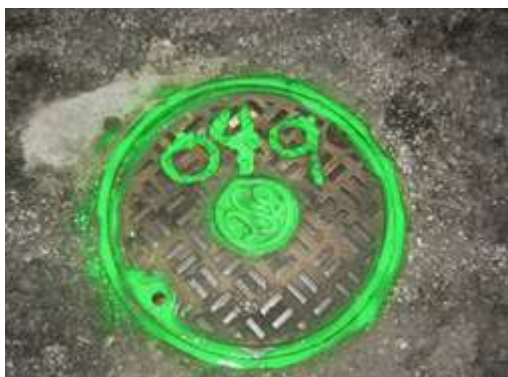
Miscellaneous

MH Lid

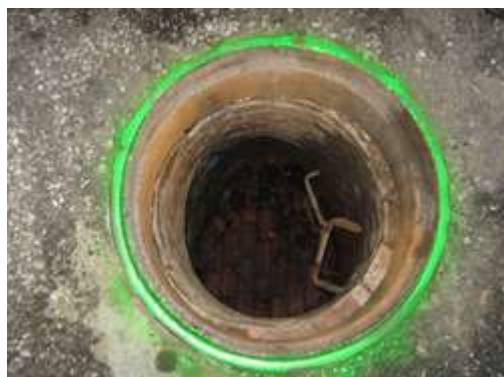
Miscellaneous

Frame View

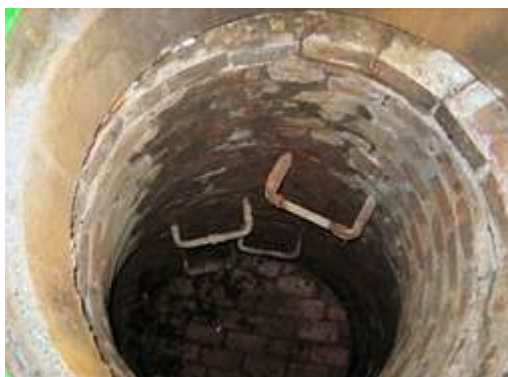
Defect 5

Infiltration: ☐ None ☐ Joint ☐ Cracks ☐ Mortar ☐ Roots ☒ **Wall**

Count: **4** Missing: **0** ☒ **Corroded**

chimney wall infiltration; corroded rungs

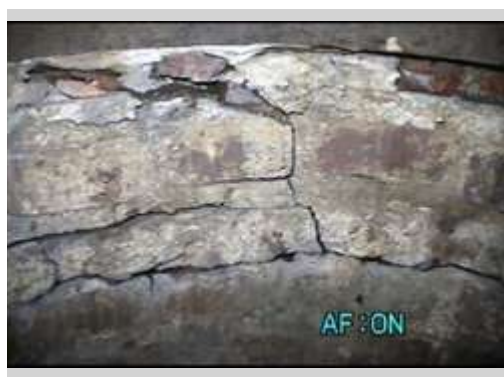
Defect 3

Condition: ☐ Sound ☒ **Cracked** ☐ Root Intrusion ☐ Loose Brick ☒ **Deteriorated**

cracked & deteriorated chimney

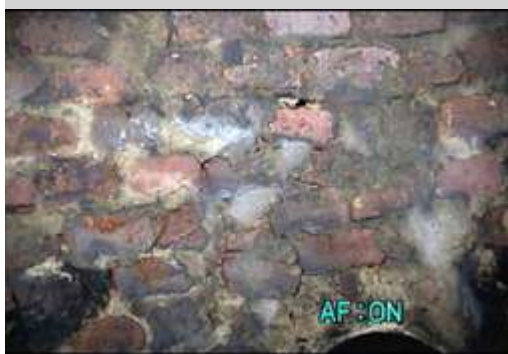
Defect 1

Condition: ☐ Sound ☐ Cracked ☐ Root Intrusion ☐ Loose Brick ☒ **Deteriorated**

deteriorated barrel

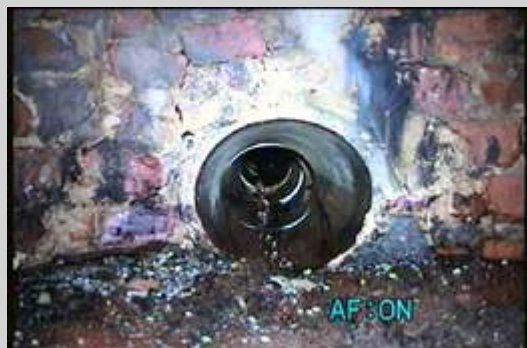
12 O'Clock Outflow

8 in. Circular Gravity Sewer
Pipe Out @ 12 O'Clock
